## **MARINE INVESTIGATION REPORT**

**M99F0023**

### **ENGINE-ROOM FIRE**

**THE SELF-UNLOADING BULK CARRIER “NANTICOKE”  
AT 39°20' N, 072°22' W, WESTERN NORTH ATLANTIC OCEAN**

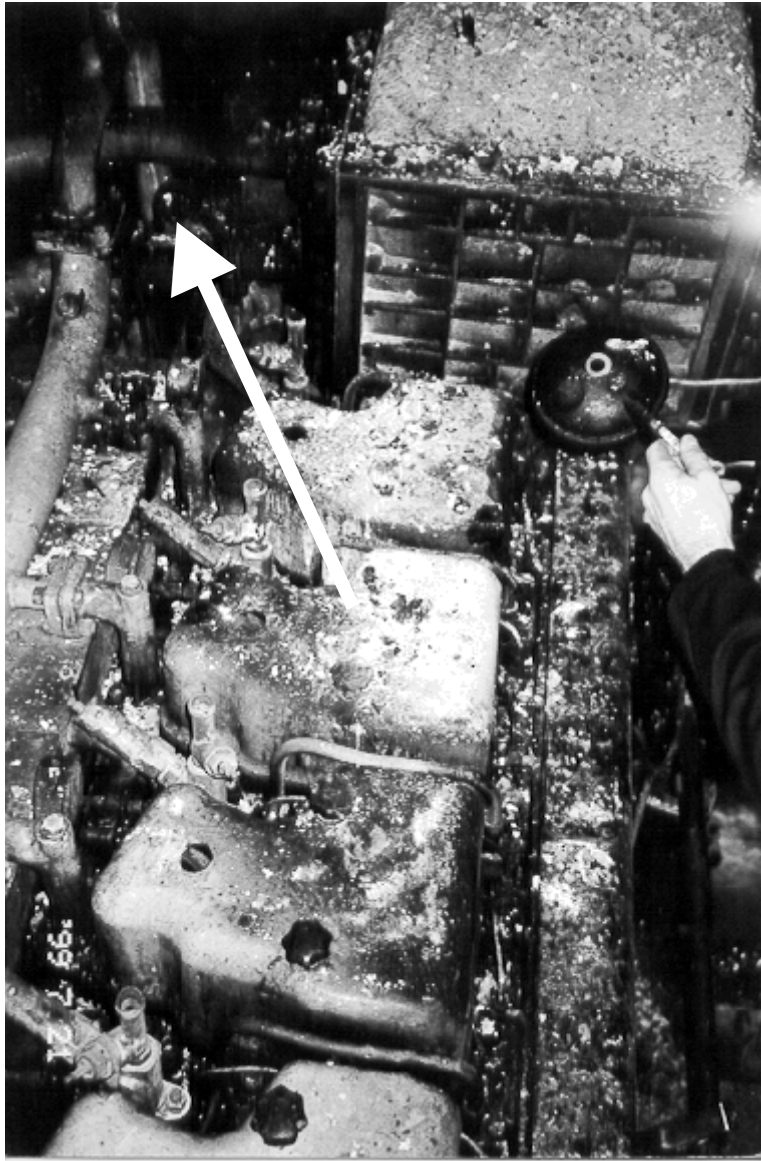
A vertical, V-shaped soot pattern was present on the port generator exhaust uptake as well as a horizontal soot pattern on valve covers 1, 2 and 3, both originating in the vicinity of the exhaust manifold/turbocharger inlet area. Aft surfaces of the valve covers had been "shadowed" from the fire even though their top surfaces were burned and sooted. An area of "clean burn" damage was present on the cable tray directly above the fuel filters.

The vertical soot patterns on the exhaust uptake, the horizontal patterns on top of valve covers 4, 5 and 6, and the shadowing on the aft surfaces of the same valve covers, indicate a fire origin at the engine’s port side, forward of cylinder head No. 1. The most probable high temperature ignition sources in this area are the indicator cock protruding from the cylinder head and the uncovered exhaust manifold connecting to the turbocharger.

**HORIZONTAL CHARRING PATTERN POINTING TOWARDS  
THE SEAT OF THE FIRE AT THE EXPOSED EXHAUST PIPING**

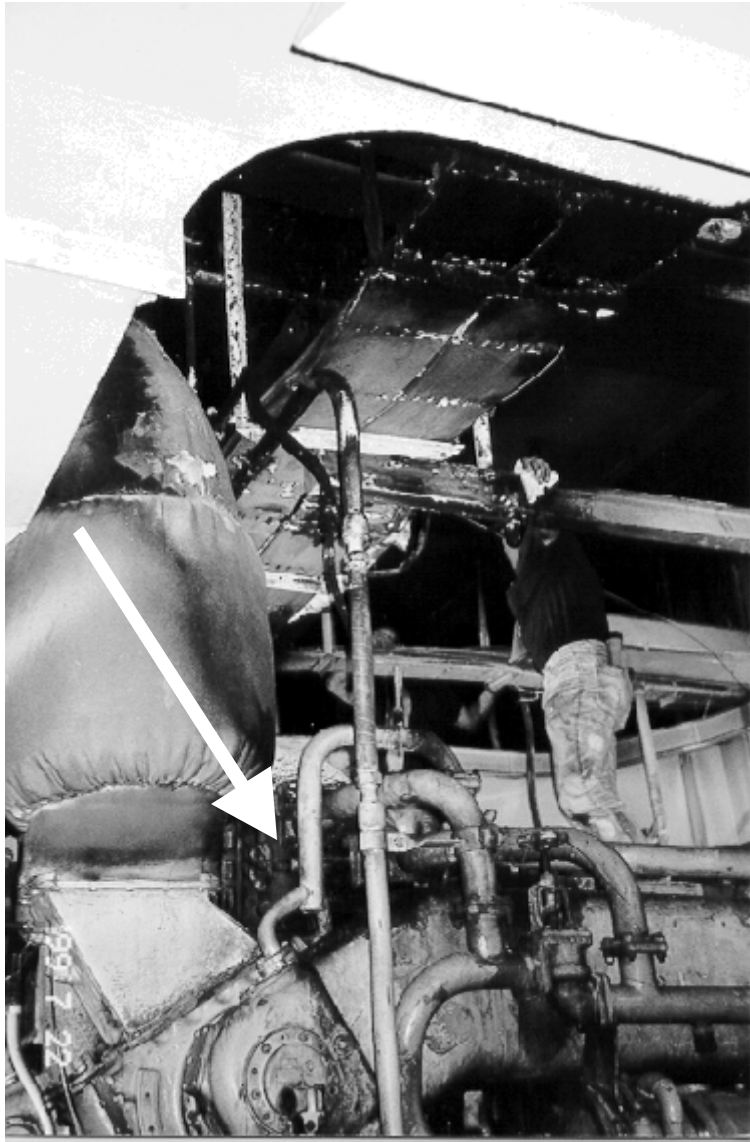
**VERTICAL SOOT PATTERN INDICATING THE SEAT OF FIRE  
NEAR EXHAUST MANIFOLD AT INLET TO TURBO-CHARGER**

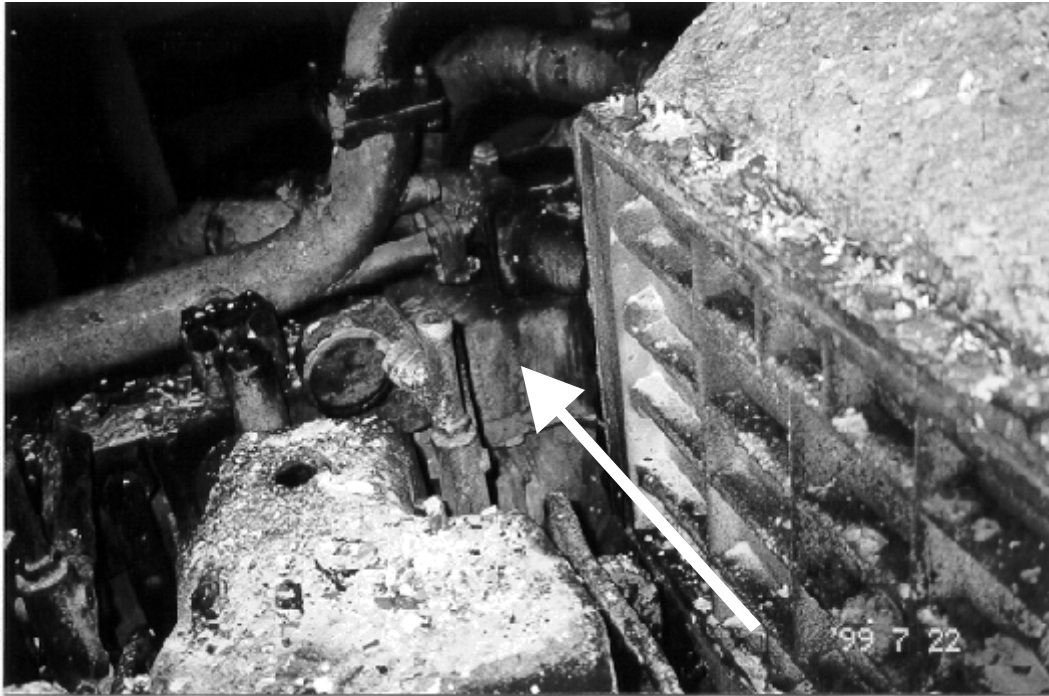
Outboard of cylinder No. 1 are the exhaust collector pipes which lead to the turbocharger mounted on the forward end of the engine. No lagging or shielding was present on the exhaust pipes where they connected to the turbocharger. An indicator cock protruded from each cylinder head just forward and outboard of the valve covers.

3. The port generator forward fuel filter was in service at the time of the fire.
4. The location of the forward fuel filter allowed leaking fuel to contact an adjacent, unshielded hot exhaust manifold and indicator cock.
5. No inspection rounds of the engine-room were made between 1515 and 1600, the time at which the fire was discovered.
6. Vessels built before 1 September 1984 were not required to have wiring for duplicated steering power and control systems in separated cable runs.
7. The fire extensively damaged the main power and control wiring for the vessel's duplicated steering systems, which ran together in a common cable tray above the generator.

**EXPOSED EXHAUST MANIFOLD ADJACENT NO. 1 CYLINDER HEAD**

- New top covers have been installed on all generator fuel filters.
- Metal shields have been installed between filters and adjacent hot exhaust surfaces to prevent contact in the event of filter leakage.
- The steering control and power wiring have been re-routed so that they do not pass over the generators' forward ends.
- An internal safety bulletin has been circulated to the entire fleet apprising them of the occurrence.

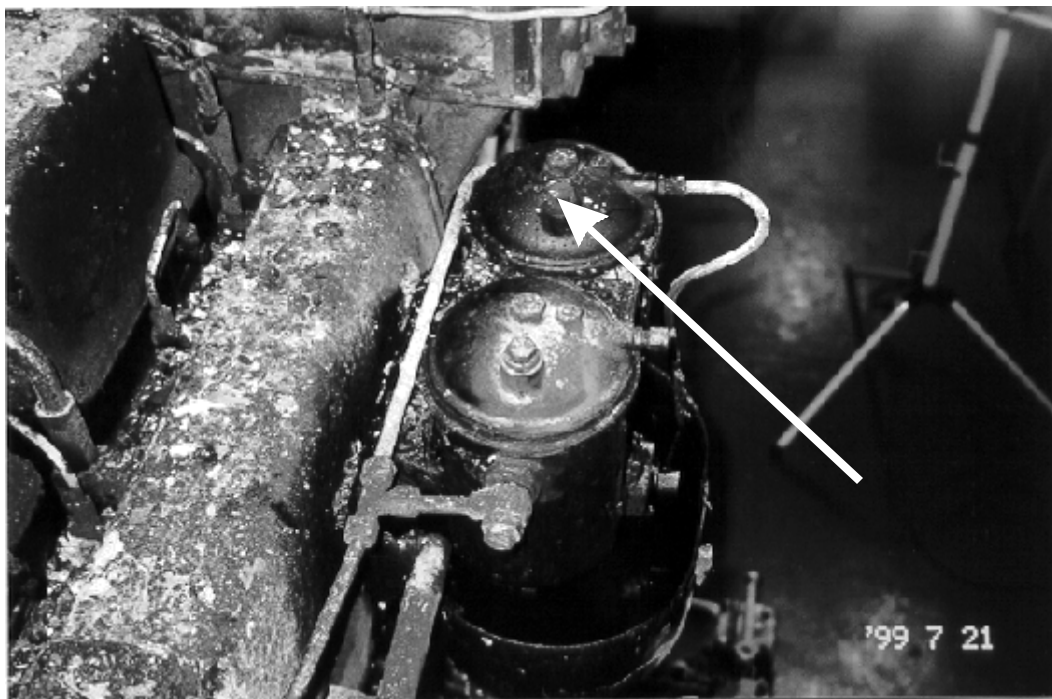
The port generator was examined by the TSB on the evening of July 21. The generator secondary fuel filters are located on the inboard forward end adjacent to valve cover No. 1. The generator secondary fuel filter selector cock was found in the forward filter position indicating that the forward fuel filter was in use at the time of the fire. Both the forward and aft filter bowls were extensively charred externally. The save-all under the fuel filters was full to within 3 cm of its upper edge with diesel oil. There was an indication that fuel had run down the starboard side of the engine under the filters.

The two fuel oil filters mounted on the starboard upper side of the engine contain fuel under pressure of approximately one bar and are mounted on the same plane as the exposed exhaust manifold and indicator cock. Examination of the fuel filters indicated that the aft filter was extensively damaged internally. This indicates that the aft filter was not cooled by fuel flow and thus not in service at the time of the occurrence. It can, therefore, be ruled out as a source of fuel to the fire. Furthermore, the position of the fuel selector cock indicated that the forward filter was in service at the time of the occurrence.

The fire was caused by a leakage of fuel, which contacted an exposed exhaust manifold, from the forward fuel filter on the port generator. Contributing to the occurrence was the modification to the fuel filter cover, the re-use of the copper sealing gasket on the cover, the unshielded hot exhaust surfaces adjacent to the filter, and the less-than-adequate engine-room watchkeeping duty during the fire drill before the occurrence.

**SECONDARY FUEL FILTERS ADJACENT NO.1 CYLINDER HEAD  
ARROW POINTS TO INITIAL LEAKAGE POINT**

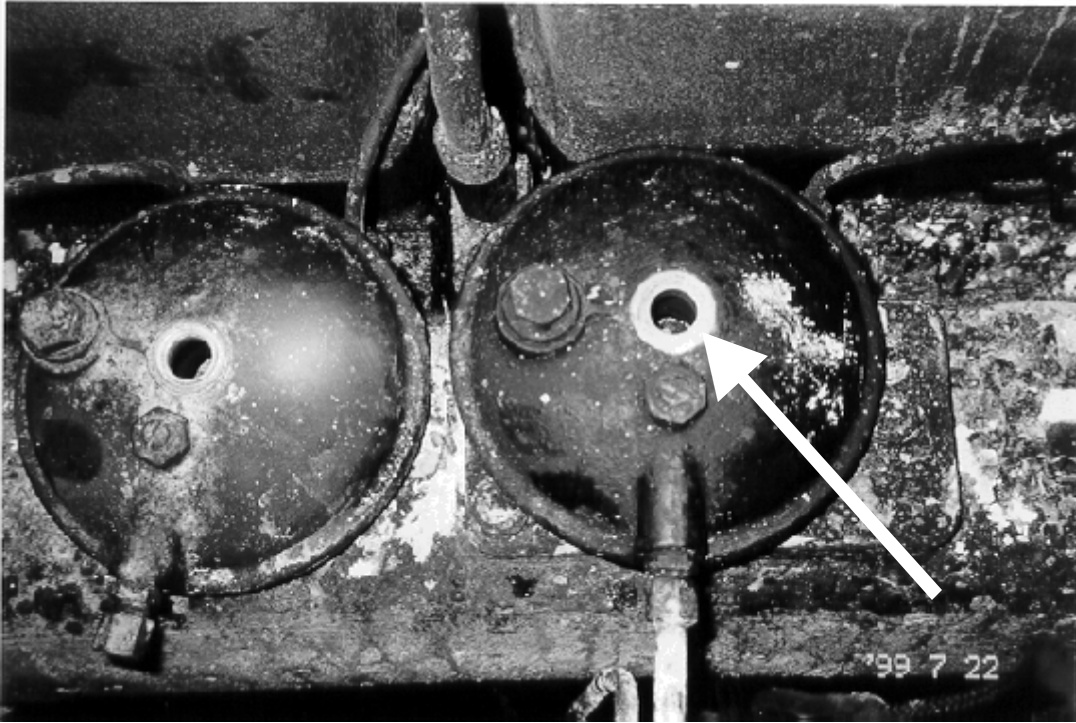
Inspection of the forward filter revealed that the cover was in place, with the centre retaining-bolt finger tight. The cover seal O-ring was melted for a distance of 3 cm on the side facing the engine, but was otherwise intact. Internally, the centre spindle rubber seal and filter basket were intact and showed no sign of heat damage. The filter bowl was two-thirds full of diesel fuel. File marks were present on the cover/bolt sealing surface and, unlike the aft filter, the cover/bolt surface was flat, with no recess.

At an unknown time before the occurrence, modifications had been made to the forward filter cover/bolt sealing surface, which removed the seating groove for the copper washer and left the sealing surface uneven and grooved with file marks. As a result, the watchkeeping engineer had experienced a problem obtaining a fuel-tight joint at the copper gasket sealing the cover to its securing bolt when he serviced the filter one hour before the fire. No new copper gaskets were available on board, so the existing copper gasket was annealed and re-used. Once a copper gasket has been deformed by use, it is more difficult to obtain a tight seal

for subsequent usage even if it has been annealed. The combination of the modified, uneven sealing surface and the re-use of the used gasket increased the risk of leakage once pressure was applied to the filter.

1. The bolt sealing surface on the forward fuel filter cover (port generator) had earlier been modified by removing the recess used to seat the copper washer. The surface was uneven and marred by file marks.
2. When the filter was serviced an hour before the fire, the copper washer was not renewed, as a spare was not available.

**COVER FROM FORWARD FUEL FILTER (RIGHT)  
MODIFIED BY REMOVAL OF THE GASKET MOUNTING GROOVE**
